BUILDING-STRUCTURE INVENTORY FORM

1. BUILDING NAME(S): Herring House
2. COUNTY: Monroe TOWN/CITY: Greece VILLAGE: ---
3. STREET LOCATION: 487 Stone Road
4. OWNERSHIP: a. public ☐ b. private ☒
5. PRESENT OWNER: Mr. & Mrs. Wesley Barager ADDRESS: (same) Rochester, NY 14616
6. USE: Original: residence Present: residence
7. ACCESSIBILITY TO PUBLIC: Exterior visible from public road: Yes ☒ No ☐
Interior accessible: Explain private residence

Town of Greece Historic Sites Survey
Monroe County, New York
487 Stone Road
page 5

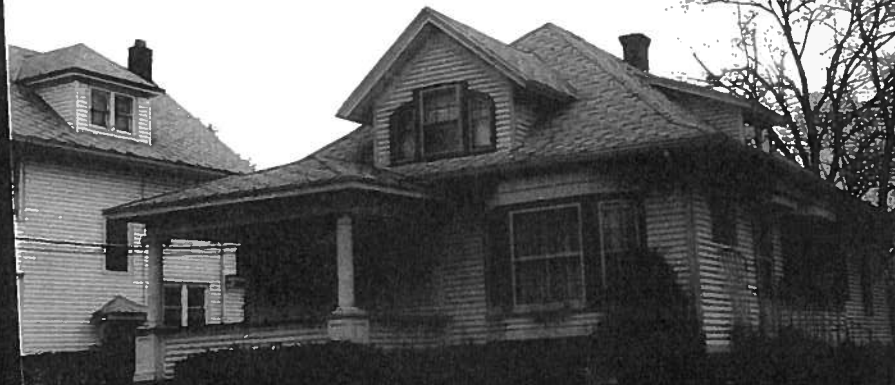
12. PHOTO:

18. One-and-one-half-story, hipped roof plan. This frame Colonial Revival style house is clad with wood clapboards. The house sits on a rock-faced, cast concrete block foundation. Fenestration is asymmetrical with mostly 1/1, double-hung windows. On the north (facade) and west elevations are cutaway window bays. On the facade, a Palladian window with 6/1 central window flanked by 4/4, curved-top windows is located in the central gabled dormer. The east elevation features a large, three-section picture window with multiple panes of glass. Six small, square windows on the east and west elevations feature a single sash with three small panes over three larger panes of glass.

The broadly pitched hipped roof has a ridgeline that runs front-to-back. The roof flares out near the corners and has a wide overhang with a frieze band below. Three attic dormers project from the roof: the gabled dormer on the facade and matching shed-roofed dormers on the east and west elevations. A brick chimney is located on the south slope of the hipped roof.

A one-story, hipped roof, open porch projects from the east end of the facade (north elevation). The porch features fluted columns and pilasters with Ionic capitals. The

columns and pilasters sit atop square, paneled wood piers. The railing area is enclosed by a clapboard-sided knee wall. The corners of the porch rest on rough-faced, cast concrete block piers. The front entrance, which might have been the main entrance (now inaccessible from the street) features a wood and glass paneled door. Secondary entrances are located on the east and west elevations. The entrance on the east elevation has an enclosed, one-story porch. The raised entrance on the west elevation features wood steps and a square, projecting (cantilevered) hood.
